- **Contract Number: CNR048**
- **Project: Interstate 24, Bridge Replacement over Spring Street and Oldham Street**
- **Date:**
- **Question:**

Subject: **Pavement Cores for I-24 Davidson County (Silliman Evans Bridge)**

## Silliman Evans Bridge Pavement Core Log

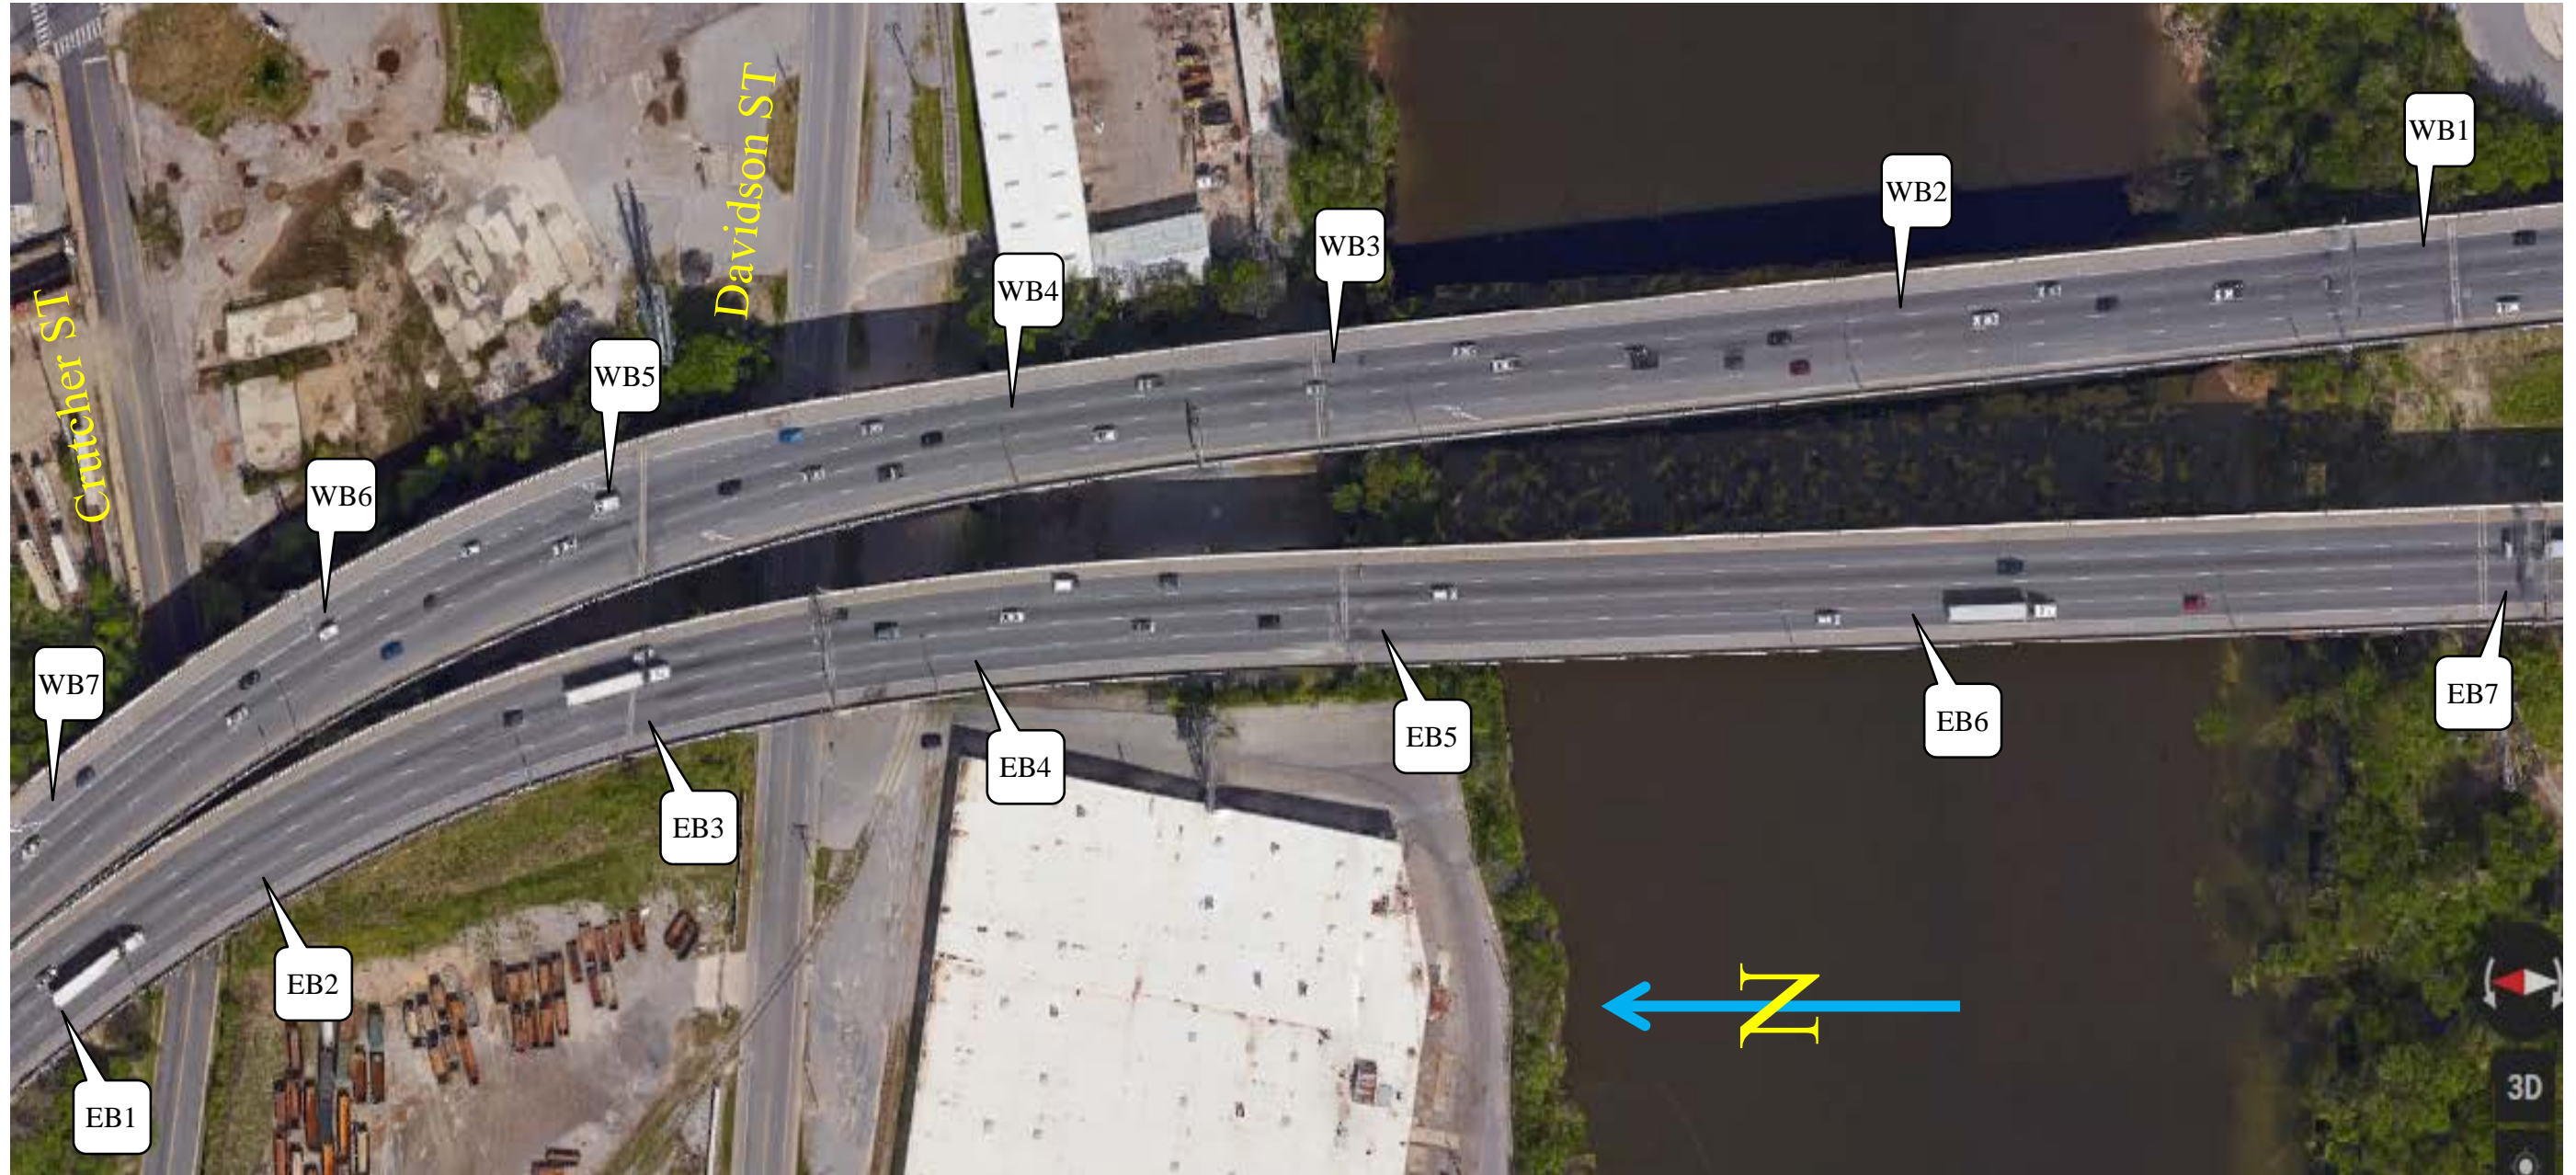
Silliman Evans Bridge Core Locations

Our office has completed an existing pavement survey of the asphalt overlay on the mainline spans of the Silliman Evans Bridge. All cores are from the rightmost lane of traffic. In general, the cores on the spans across the Cumberland River are approximately 7 inches in depth. The other spans range between 5.25 to 6.5 inches in depth. A detailed log of the cores, location map and pictures of the cores is presented in the following pages.

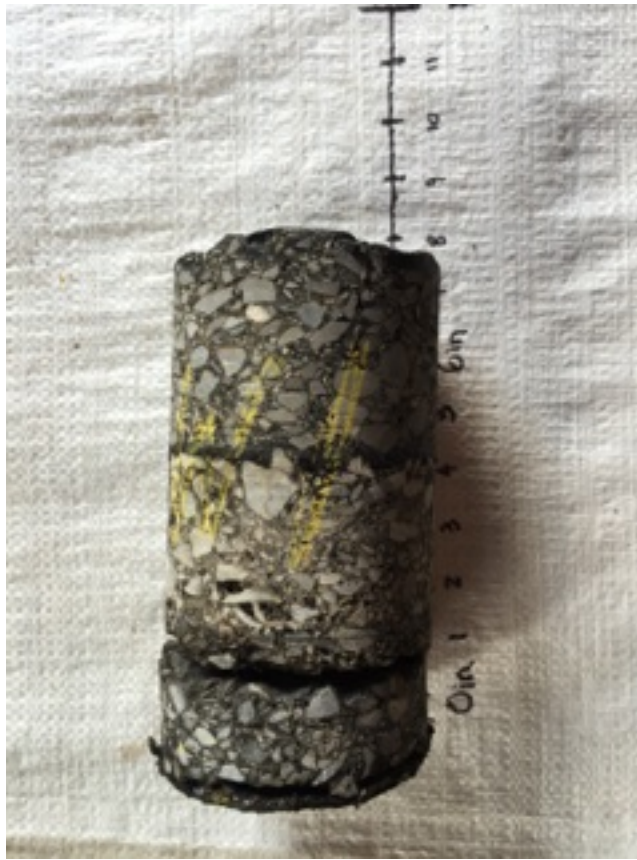
Westbound 1

Core	Asphalt Depth (in)	Span	Notes
WB1	7 ¼	Cumberland River, Joint	
WB2	7 ¼	Cumberland River, Midspan	
WB3	7	Cumberland River, Joint	Core measured 5 1/4, bottom layer crumbled, depth of hole measured to approximately 7"
WB4	6 ¼	Davidson Street, Midspan	
WB5	5 ¾ *	Crutcher Street, Joint	Two attempts were made a coring this location, but both cores disintegrated after 5 inches. Depth was obtained by measuring the hole to top of concrete.
WB6	6 ¼	Crutcher Street, Midspan	
WB7	6 ¼	Crutcher Street. Bridger End	Taken at the end of the bridge rail, no apparent bridge joint on pavement.
EB1	6 ¼	Crutcher Street. Bridger End	Taken at the end of the bridge rail, no apparent bridge joint on pavement.
EB2	6 ½	Crutcher Street, Midspan	
EB3	5 ¼	Davidson Street, Joint	
EB4	5 ½	Davidson Street, midspan	
EB5	7	Cumberland River, Joint	
EB6	7	Cumberland River, midspan	
EB7	5 ½	Span leading into split	Taken under sign bridge for Interchange 50A/50B
